# **PROVINCE LAKE WATERSHED SURVEY REPORT**

## **JANUARY 2014**

## Appendix A- Survey Maps

## Appendix (C): List of Stormwater Sites Requiring Engineering Assistance

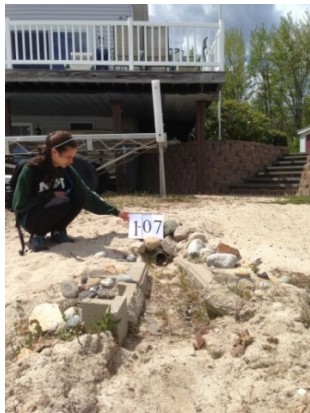
| Sector ID | Tax Map/Lot # | Address | Description | Picture |
|---|---|---|---|---|
| 1-7 | 107-14 | 118 Remick Road | Point Source - Perimeter Drains Exit on Beach | |

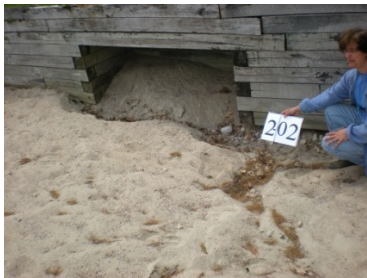
| Sector ID | Tax Map/Lot # | Address | Description | Picture |
|---|---|---|---|---|
| 2-02 | 109-4 | 141 Bonnyman Road | Moderate Surface Erosion; Lack of Shoreline Vegetation & Erosion; Beach Area<br><br>Retention wall failing | |

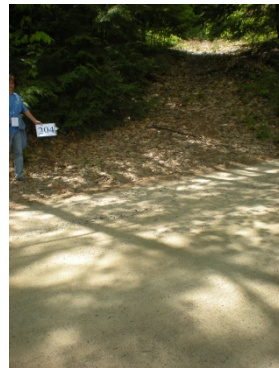
| Sector ID | Tax Map/Lot # | Address | Description | Picture |
|---|---|---|---|---|
| 2-04 | 109 | Bonnyman Road in Effingham @ Wakefield Line | Moderate Surface Erosion; Moderate Road Shoulder Erosion; Roadside Plow/Grader Berm | |

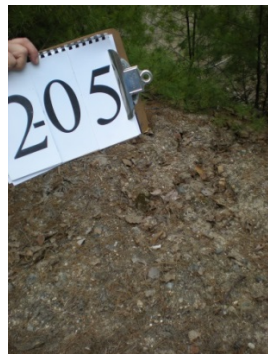
| Sector ID | Tax Map/Lot # | Address | Description | Picture |
|---|---|---|---|---|
| 2-05 | 6-3 | Bonnyman Road in front of lot 6-3 | Some buffer/Filtering, but Visible Signs of Concentrated Flow and/or Sediment Moving through Buffer to Lake (2) | |

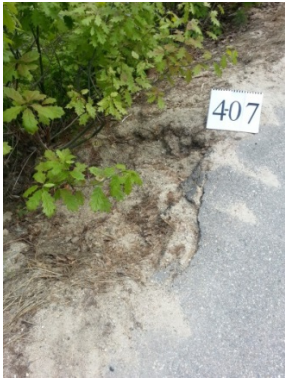
| Sector | Site | Location | Land Use | Description of Problems | Type of Erosion | Area | Impact | Cost | YCC Project |
|---|---|---|---|---|---|---|---|---|---|
| 4 | 7 | Across from 115 Bonnyman Rd | Town Road | Moderate Surface Erosion; Moderate Road Shoulder Erosion, failure | Gully (3) | Large (3) | High (8-9) | Medium | No |

| Sector ID | Tax Map/ Lot # | Address | Description | Picture |
|---|---|---|---|---|
| 4-07 | 9-92 | Across from 115 Bonnyman Rd | Moderate Surface Erosion; Moderate Road Shoulder Erosion, road failure | |

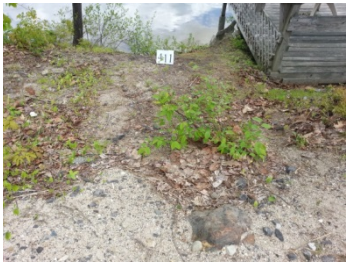
| Sector | Site | Location | Land Use | Description of Problems | Type of Erosion | Area | Impact | Cost | YCC Project |
|---|---|---|---|---|---|---|---|---|---|
| 4 | 11 | Across 111 Bonnyman Rd | Beach Access | Slight Surface Erosion; Slight Road Shoulder Erosion; Unstable Access; Failing Retaining Wall | Sheet (1) | Small (1) | Low (3-5) | Medium | No |

| Sector ID | Tax Map/ Lot # | Address | Description | Picture |
|---|---|---|---|---|
| 4-11 | 9-93 | Across 111 Bonnyman Rd | Slight Surface Erosion; Slight Road Shoulder Erosion; Unstable Access; Failing Retaining Wall | |

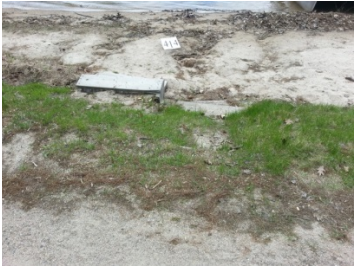
| Sector | Site | Location | Land Use | Description of Problems | Type of Erosion | Area | Impact | Cost | YCC Project |
|---|---|---|---|---|---|---|---|---|---|
| 4 | 14 | Towle Farm Road | Private Road | Moderate Surface Erosion; Moderate Ditch Erosion & Bank Failure; Moderate Road Shoulder Erosion | Gully (3) | Large (3) | High (8-9) | High | No |

| Sector ID | Tax Map/ Lot # | Address | Description | Picture |
|---|---|---|---|---|
| 4-14 | | Towle Farm Road | Moderate Surface Erosion; Moderate Ditch Erosion & Bank Failure; Moderate Road Shoulder Erosion | |

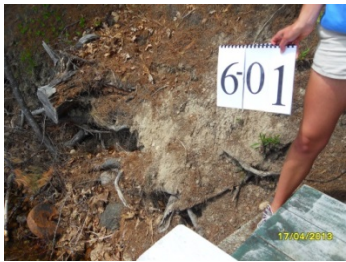
| Sector ID | Tax Map/Lot # | Address | Description | Picture |
|---|---|---|---|---|
| 6-01 | 105-1/2 | 19 Oak Avenue | Undercut Shoreline | |

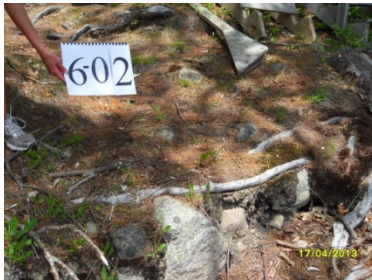
| Sector ID | Tax Map/Lot # | Address | Description | Picture |
|---|---|---|---|---|
| 6-02 | | Next to 42 Oak Avenue | Moderate Surface erosion; Undercut and eroded Shoreline | |

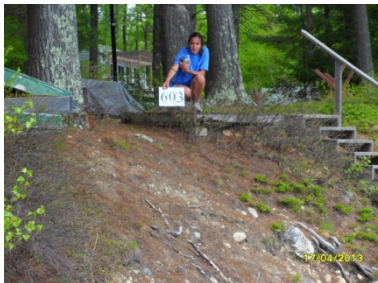
| Sector ID | Tax Map/Lot # | Address | Description | Picture |
|---|---|---|---|---|
| 6-03 | | 42 Oak Avenue | Some buffer/Filtering, but Visible Signs of Concentrated Flow and/or Sediment Moving through Buffer to Lake (2) | |

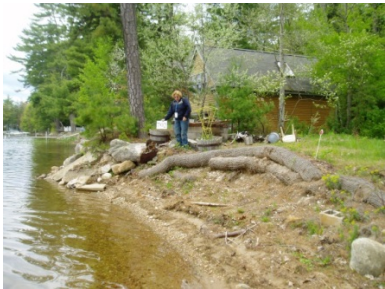
| Sector | Site | Location | Land Use | Description of Problems | Type of Erosion | Area | Impact | Cost | YCC Project |
|---|---|---|---|---|---|---|---|---|---|
| 7 | 2 | 219 Bailey Road | Residential | Severe shoreline erosion, failed coir log installation | Rill (2) | Medium (2) | Medium (6-7) | Medium | No |

| Sector ID | Tax Map/Lot # | Address | Description | Picture |
|---|---|---|---|---|
| 7-02 | 101-1 | 219 Bailey Road | Severe shoreline erosion, failed coir log installation | |

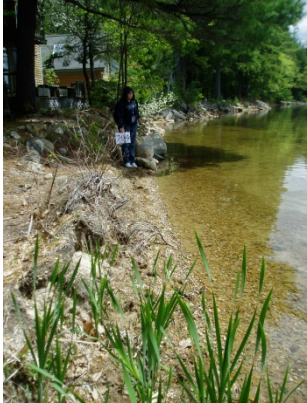
| Sector ID | Tax Map/Lot # | Address | Description | Picture |
|---|---|---|---|---|
| 7-04 | 101-3 | Senter Lane | Undercut Shoreline and Erosion | |

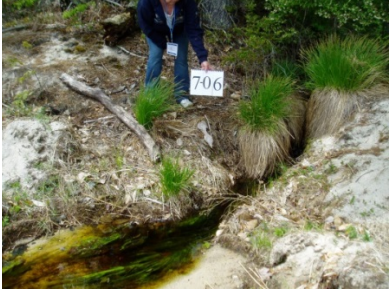
| Sector | Site | Location | Land Use | Description of Problems | Type of Erosion | Area | Impact | Cost | YCC Project |
|---|---|---|---|---|---|---|---|---|---|
| 7 | 6 | End of Lakeshore Drive | Shoreline | Inadequate Shoreline Vegetation; Erosion; Unstable Access; Algal filled stream outflow | Sheet (1) | Medium (2) | Low (3-5) | Low | No |

| Sector ID | Tax Map/Lot # | Address | Description | Picture |
|---|---|---|---|---|
| 7-06 | 106-3 | End of Lakeshore Drive | Inadequate Shoreline Vegetation; Erosion; Unstable Access; Algal filled stream outflow | |
